# A study on the Slope Instability Problems and Mitigation Measures for the Road Failure from Gebre Guracha to Lumame Road Segment

Habtamu Washe Mite <sup>1</sup>, Prof. Emer T. Quezon <sup>2</sup>, Tadesse Abebe<sup>1</sup>

<sup>1</sup> Department of Geotechnical Engineering, Faculty of Civil and Environmental Engineering, Institute of Technology, Jimma University, Jimma, Ethiopia

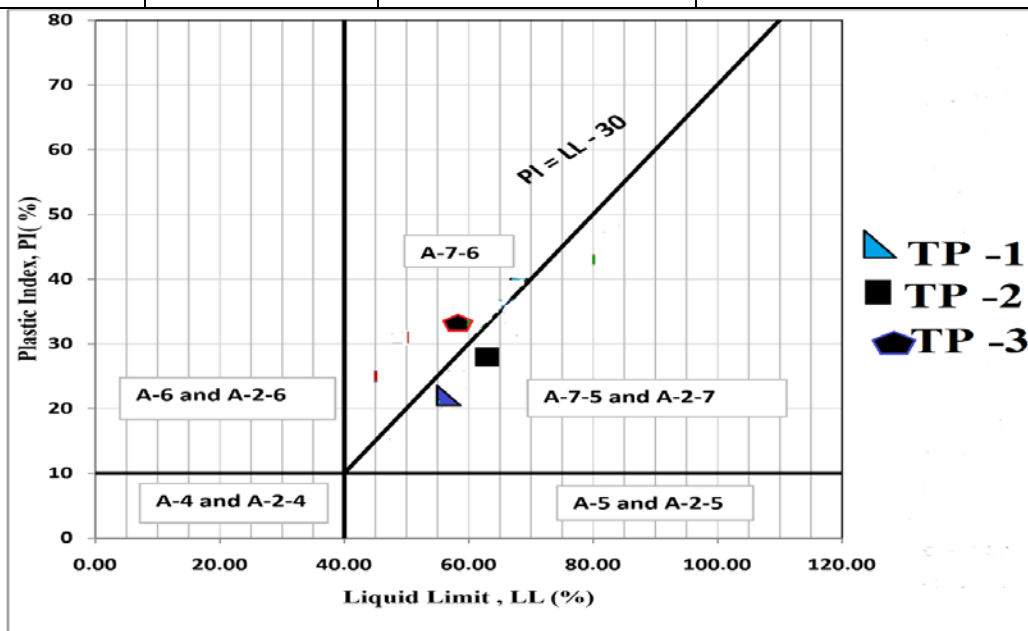
Figure 3.1: Plasticity chart of soil in the study area according to AASHTO classification system

With these test results, soil classification using the Unified Soil Classification System (USCS), TP-1 and TP-2 were the type of CH i.e. clay with high plasticity soil and TP-3 was MH i.e. silt soil with high plasticity

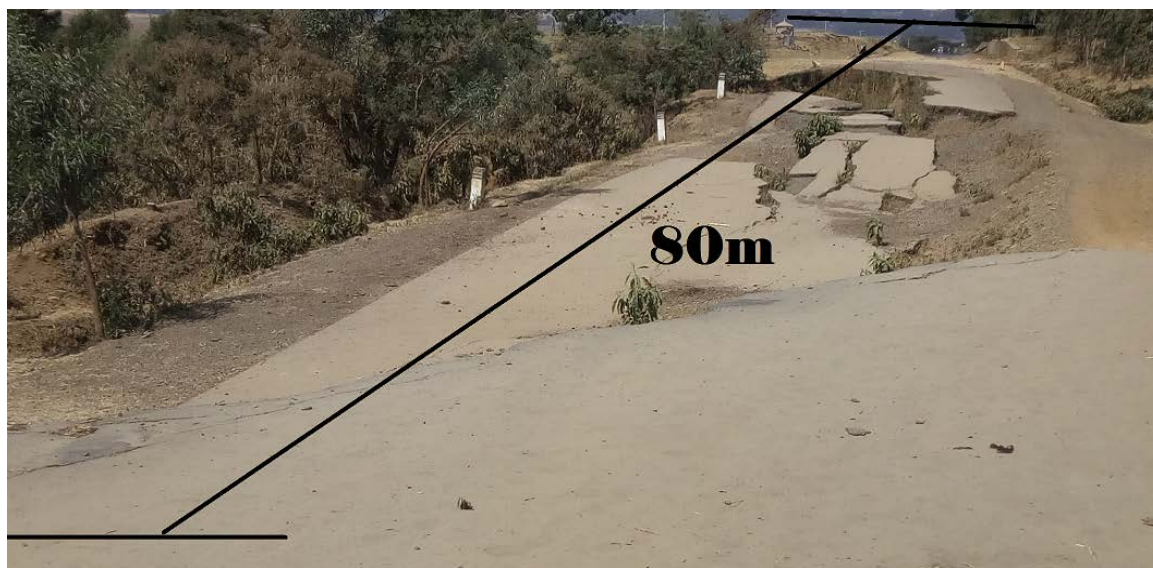
**Figure 3.4: slope failure/slide characterize**

During the investigated of the slide by digging the three test pits; the depth of test pit is 3m. In this study undisturbed and disturbed soil samples was taken from the slide plane and slide material and tested for classification, strength determination and hence for the characterization of the slide mass. From the tests, one can determine the strength parameters and index properties for the slide plane and index properties for slide mass, which eventually is used to characterize the slide mass and sliding plane.

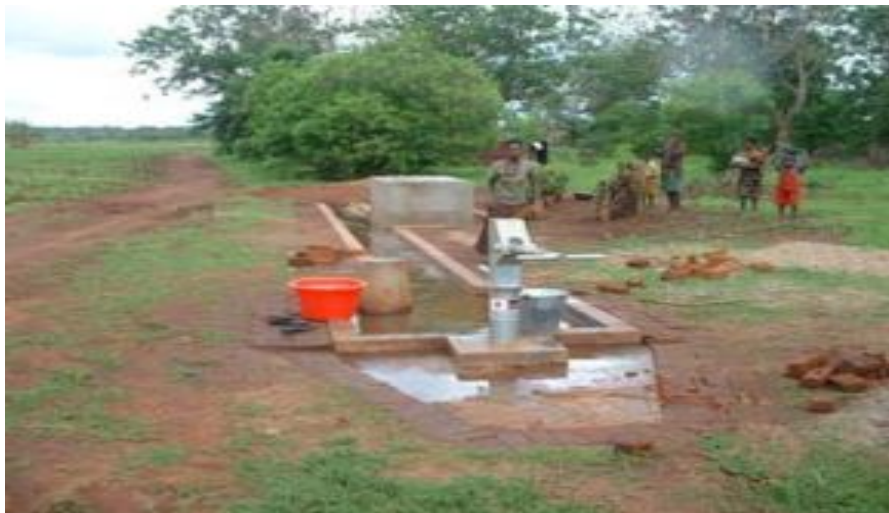
**Figure 3. 6: Photo of well-1**

**Well – 1:** This well is public use domestic well. It is found around the slide toe . the distance between the well and the slide toe is 20m. the depth of the well is 5m from the natural ground level and the depth of ground water table from natural ground level varies from 3m to 4m. At rainseason the depth of ground water level 3m from ground level.

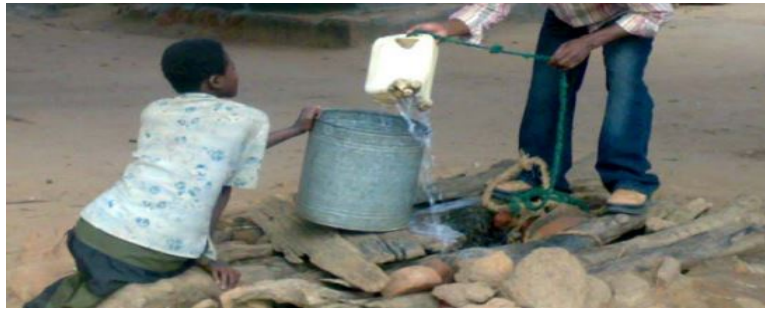
Figure 3. 1 : Photo of well-2

**Well -2:** This domestic well is Ato Melese Lakew's well. It is found around the crown of slide. the distance between the well and the slide toe is 30m. the depth of the well is 7m from the natural ground level and the depth of ground

water table from natural ground level varies from 4m to 5m. At rainy season the ground water level 4m from ground water level.

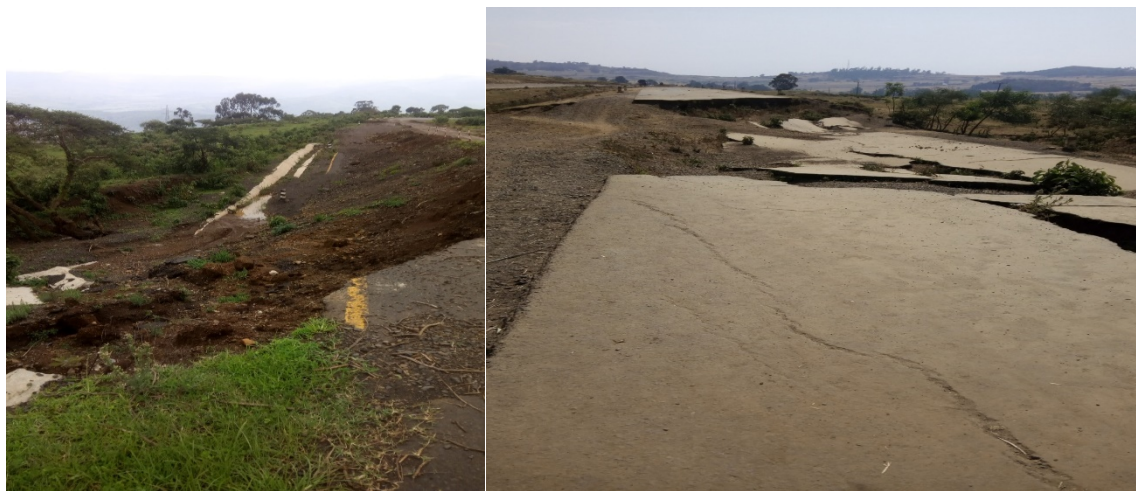
Figure 3. 2: Some Photos of the Site

In addition to these, it was attempted to identify the damages caused by the landslide on infrastructure.

The main causes of the landslide of in the study site were; pore water pressure, slope of the ground, dynamic load due traffic and erosion of toe.

From results of the investigation, the proposed remedial solutions for the remediation of the failed slope are the combinations of: **Control works:** Providing drain pipeline in the slope; Surface drainage: provide furrow ditch at the top of the crown to collect surface drainage out of the slide area; Subsurface drain: providing the horizontal and incline drain pipe in the slide area. **And Restraint works:** selected to be reinforced cantilever retaining wall, due to the following reasons: The failure is due to the undermining of the toe of the slope coupled with the increase of shear stresses due to rainfall, and a rigid structure can accommodate such failures; The free height of the retaining wall to be provided will be short as much failed soil mass shall be removed by flattening of the slope or reducing the overall slope angle; Construction material selected fill, can be produced on-site at reasonable distances and good workmanship can be achieved.

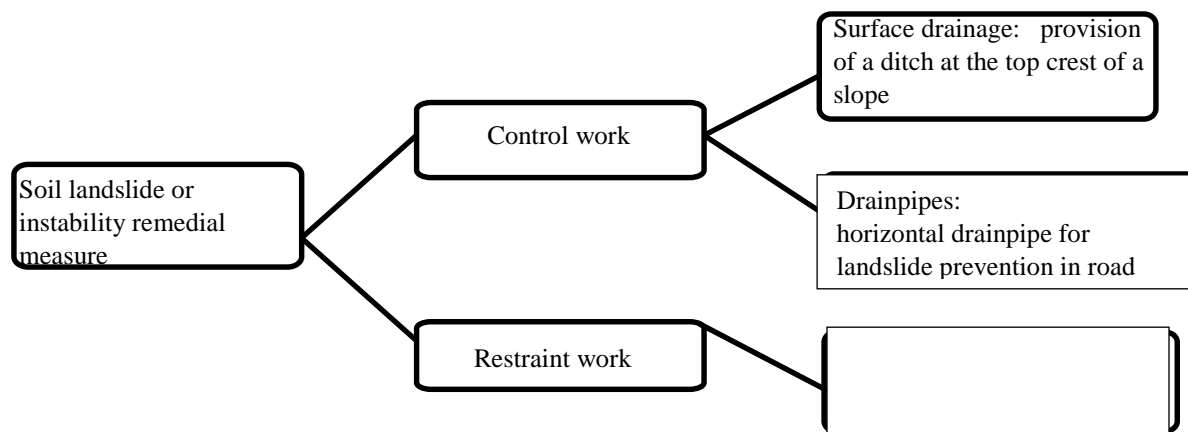
Figure 3.11: soil slope instability or landslide countermeasures

**Control works** are the methods to avoid or reduce the triggering factors, i.e., up rise of groundwater level, proper surface drainage, and proper subsurface water by using draining pipes. And **Restraint measures**- stabilize the landslide by a construction of structures to counteract the driving force of the landslide. Remedial measure may be sufficient to minimize the effect of rainfall triggered landslide, most remedial works usually involve a combination of two or more methods. Generally, the selection of appropriate remedial measures depends on engineering feasibility, economic viability, and environmental acceptability [1].

In this study, the list of remedial measures proposed and designed for respective slide locations are outlined below.
